CGU HS Committee on River Ice Processes and the Environment
17th Workshop on River Ice
Edmonton, Alberta, July 21 - 24, 2013

River Kymijoki Ice Phenomena and Water Quality

Tom Kokkonen¹ and Matti Leppäranta²

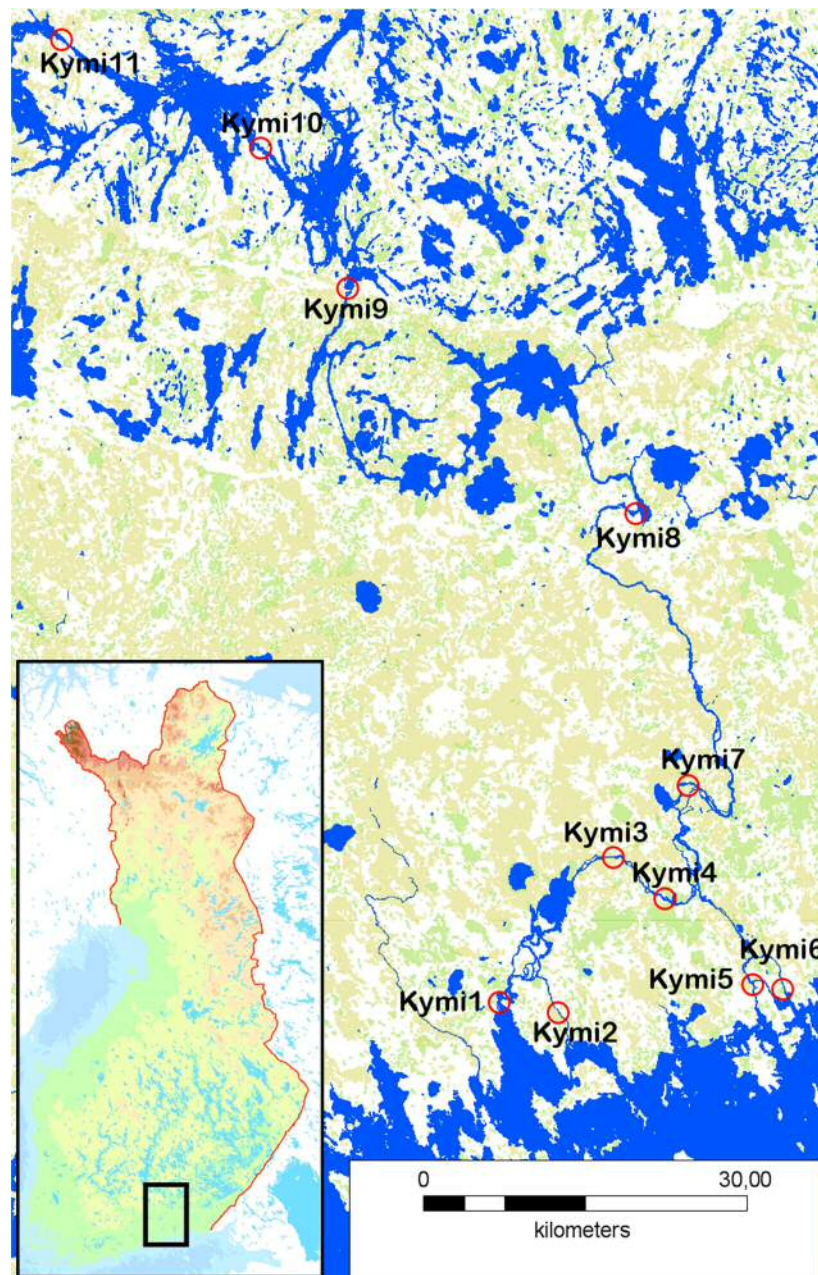
Figure 1. Measurement points at the River Kymijoki (map info: National Land Survey of Finland 2012).

The measurement points were chosen so that there are points at the main branch and all of the divided branches (Figure 1). Measurement points were named from Kymi1 to Kymi11. They were also chosen so that all of different flow conditions are covered. Some of the points are in the vicinity of frazil ice booms (Kymi3, -4, -5 and -6) (Figure 2), some are at freely flowing points (Kymi2 and -7) and some of the points are at the locations of annual anchor ice problems and anchor ice blastings (Kymi5) (Figure 3).

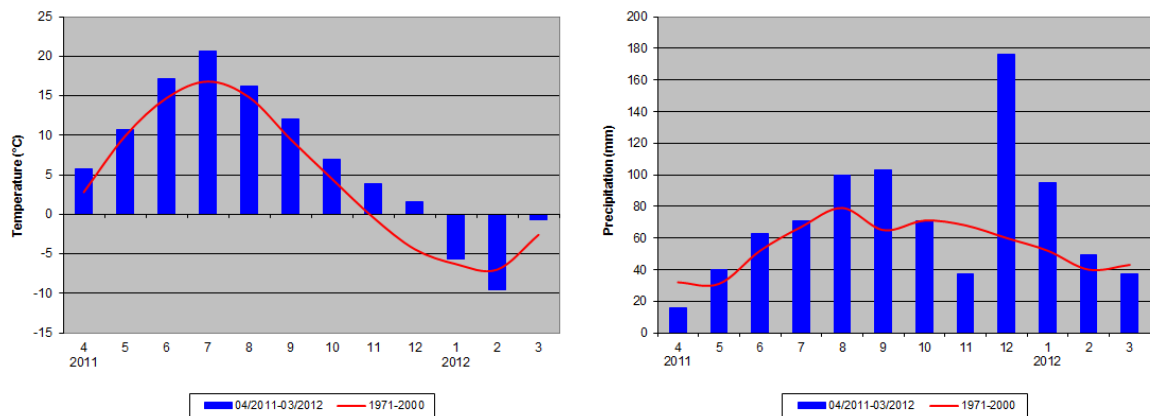
Figure 4. Temperature and precipitation in 4/2011-3/2012 and long-term averages (1971-2000) at Anjala, Kouvola (lower part of the River Kymijoki) (Finnish Meteorological Institute 2011 and 2012).

Summer and fall 2011 were warmer than the average in the River Kymijoki region (Figure 4). At the beginning of year 2012 temperatures dropped suddenly which caused frazil ice problems. Minimum temperature in the winter 2012 was -28.2 °C (Finnish Meteorological Institute 2012). It was measured at Anjala, Kouvola at the lower part of River Kymijoki in 5 February 2012. Precipitation was much higher than normal in the early fall and December 2011 (Figure 4), which influenced a lot to the river discharge (Figure 5) and ice formation.

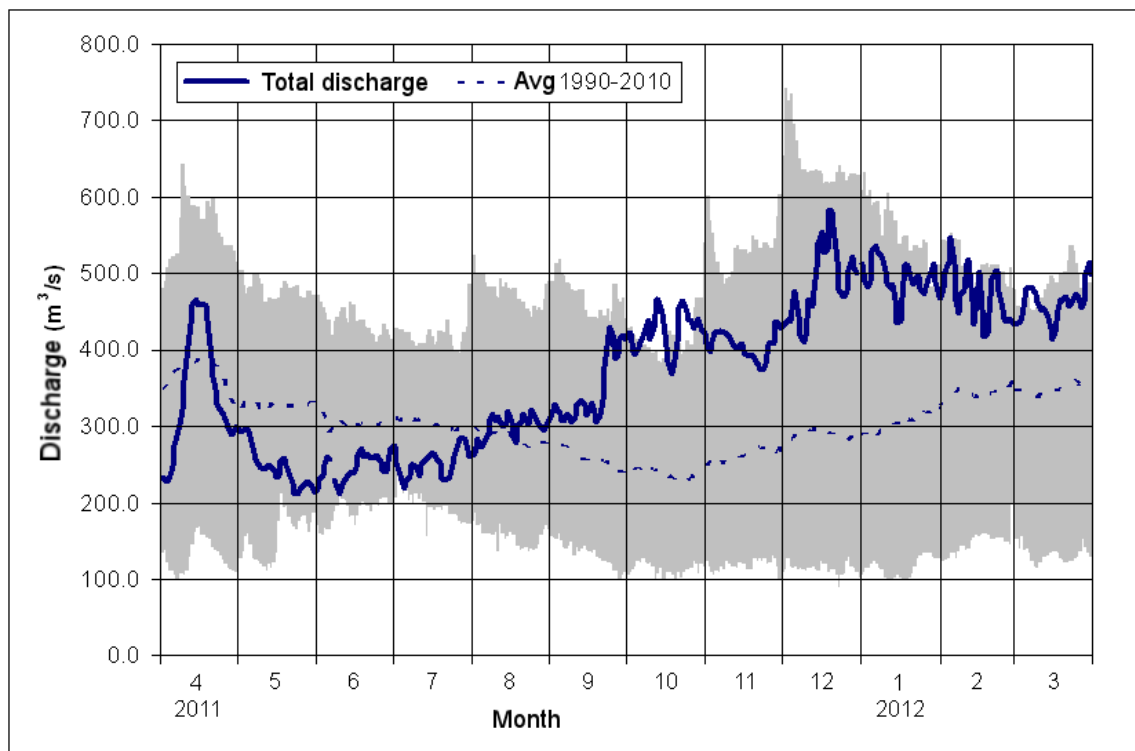
Figure 5. Total discharge at the River Kymijoki 1 April 2011 – 31 March 2012, long-term average (1990-2010) (dotted line) and range (1990-2010) (gray area) (OIVA - Environment and geographical information service for specialists 2012).

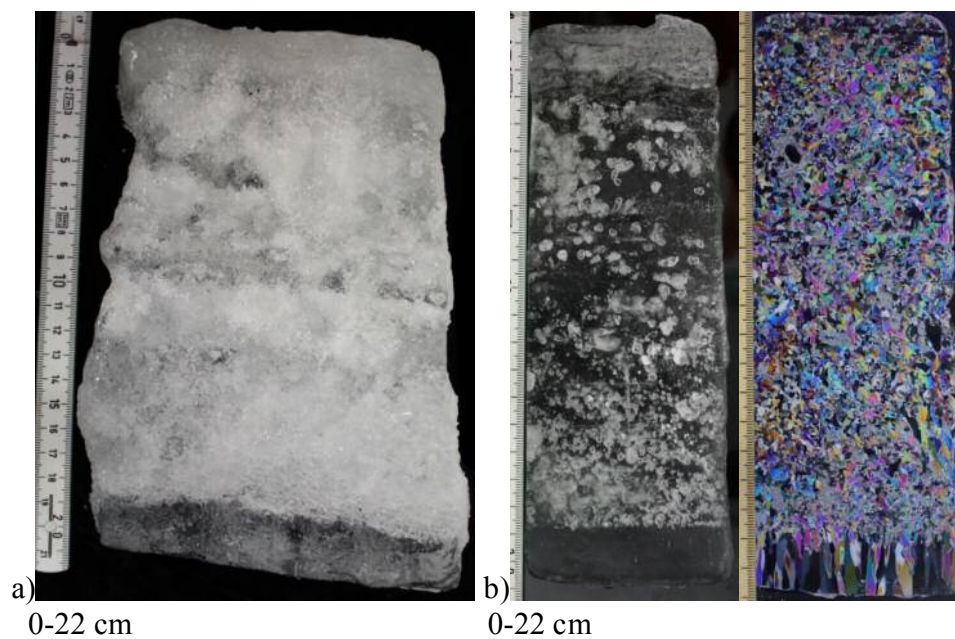
Figure 6. Kymi1 ice samples a) whole ice block, b) thick sample in normal light (left) and thin section in polarized light (right).

There was only some border ice at site Kymi1. Total thickness of the ice was 22 cm and there was 5 cm of partly melted snow on top of the ice. The ice sample was taken from the western bank of the river. The sampling site was approximately 100 meters downstream from the hydropower plant. From the full vertical ice sample in Figure 6-a it can be seen that the ice was quite opaque ice except approximately 2 cm layer of clear ice at the bottom.

It can be seen from the thick section (Figure 6-b) that the opaque layer has a lot of gas bubbles. In the top 3 cm layer there is a cloudy band where the diameter of the bubbles was less than 1 mm. Next layer (3-10 cm from top) has less gas bubbles than the top layer and their diameter is 2-5 mm. These two layers have probably formed from melted snow. The next layer (10-19 cm from top) has a lot of round gas bubbles, which diameter is approximately 1 mm. The concentration of bubbles increases to the bottom so this layer has probably formed from frazil ice that was stuck on the border of river and frozen solid. Ice has pushed impurities downwards while freezing and that's why the concentration of gas bubbles increases to the bottom. The last 2 cm layer at the bottom is clear ice with no impurities.

It can be seen from the thin section (Figure 6-b) that the top layer (0-19 cm) has a lot of small rounded and needle like grains which diameter is approximately 1-3 mm. At the bottom 2 cm layer there is congelation ice that has columnar grains. Grains are approximately 5 mm wide and 20 mm long.

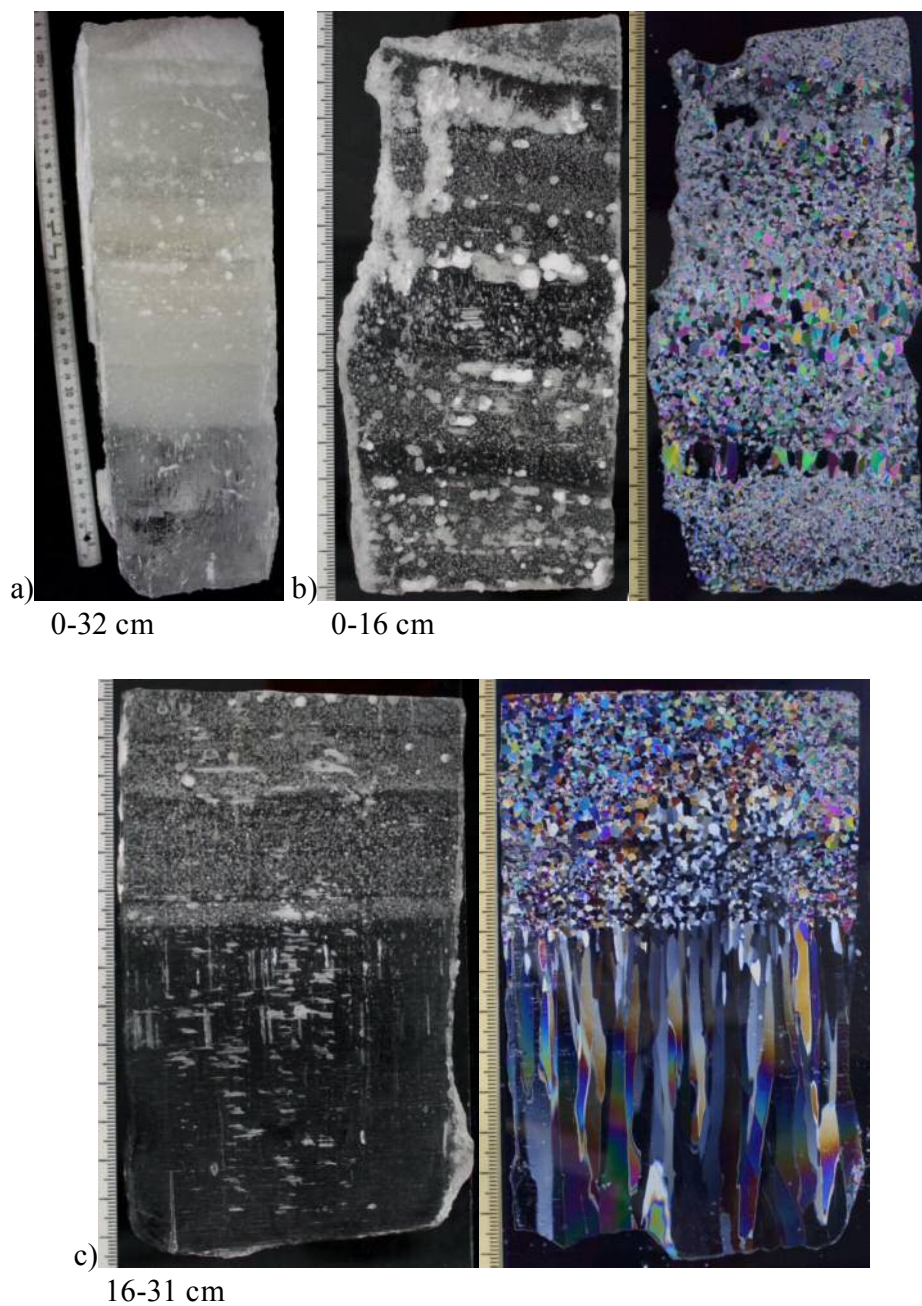
Figure 7. Kymi2 ice samples a) whole ice block, b) and c) thick sample in normal light (left) and thin section in polarized light (right).

At the sampling site Kymi2 there was a stationary ice cover on the river. The total thickness of the ice was 32 cm and there was 15 cm of snow on top of the ice. In the middle of the river snow was partially melted. Ice sample was taken from the middle of the river. From the full vertical ice sample in Figure 7-a it can be seen that approximately 20 cm from top is quite opaque ice and the bottom 12 cm is clear ice. Different layers are visible in opaque part. In the middle of the sample there was a bit more brown section where probably are some sediments in the ice.

From the thick section samples in Figures 7-b and 7-c it can be seen that there is a lot of small gas bubbles which diameter is less than 1 mm and they form cloudy bands. There are also bigger gas bubbles (diameter approximately 5 mm) that are quite uniformly distributed at the opaque snow ice and frazil ice. Top layer (0-2 cm from top) has only small gas bubbles and it is probably formed of snow. At the bottom part of the opaque ice (over 16 cm from top) there are two layers where gas bubble concentration increases to the bottom. One of these layers has probably been the first ice layer that has formed from the frazil ice.

It can be seen from the thin sections (Figures 7-b and 7-c) that the opaque part has really small snow ice and frazil ice grains which diameter is approximately 1-5 mm. at 12-13 cm from top there is a layer that has larger columnar grains. This layer has probably formed from water that has flooded on top of ice. The bottom 8 cm layer is congelation ice and the grains are columnar. The width of the grains is 3-10 mm and they are as long as the congelation ice layer.

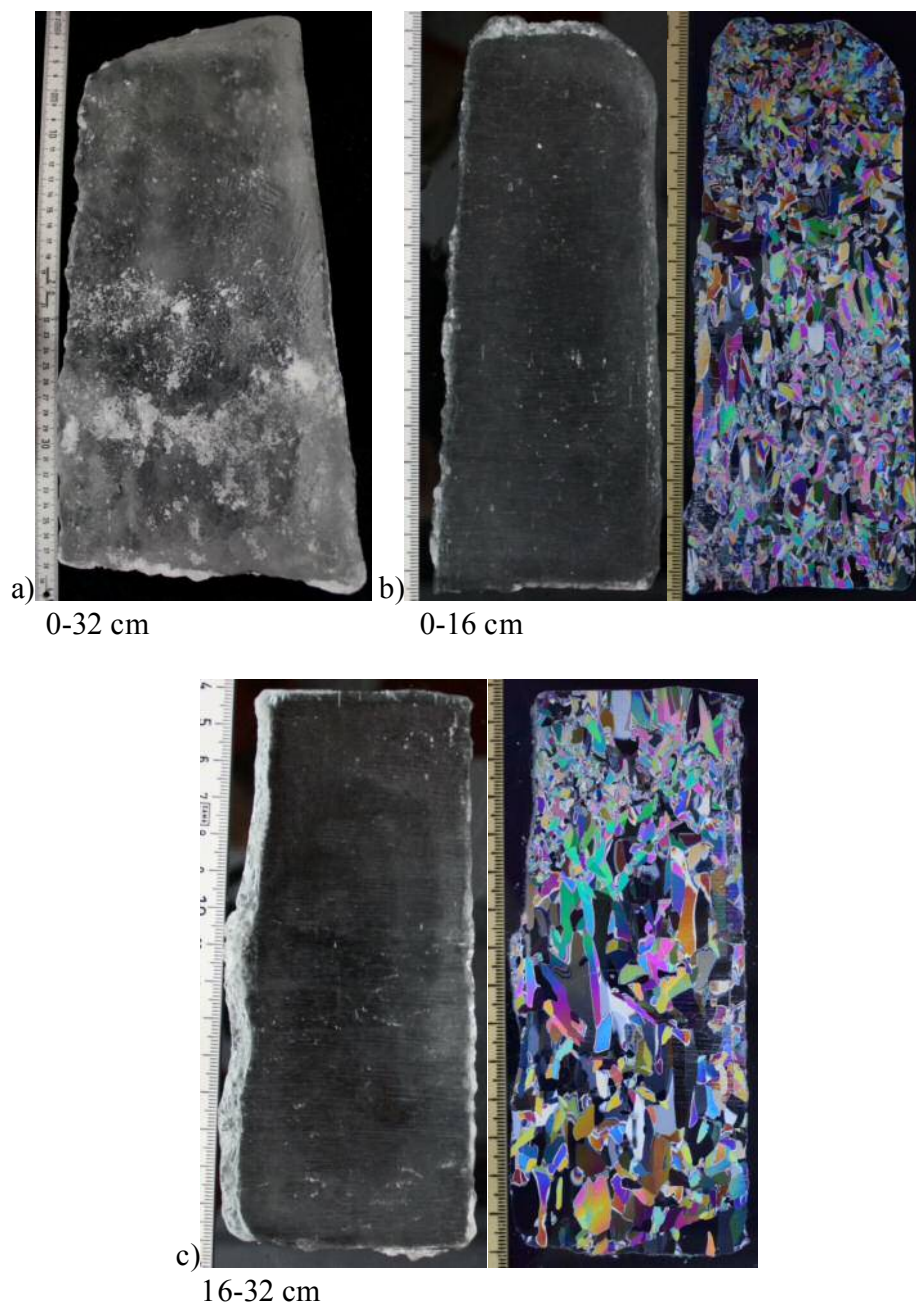
Figure 8. Kymi3 ice samples a) whole ice block, b) and c) thick sample in normal light (left) and thin section in polarized light (right).

At the sampling site Kymi3 there was only some border ice and steadier ice cover at the bend of the river. The total ice thickness was 32 cm and there was 30 cm of snow on top of ice. The ice sample was taken from the river bend from the northern bank of the river. From the full vertical ice sample in Figure 8-a it can be seen that the ice sample is quite clear ice. There are few gas bubbles only in the top 10 cm layer.

It can be seen from the thick section samples (Figures 8-b and 8-c) that there are only few gas bubbles with diameter of approximately 1-2 mm. This indicates that the ice had formed in quite steady conditions. Some bed sediments can be seen throughout the sample.

From the thin sections (Figures 8-b and 8-c) it can be seen that the whole ice sample was congelation ice with columnar grains. On top layer (0-20 cm from top) grains are approximately 5-20 mm long and 1-5 mm wide. At the bottom of the sample grains are bigger. They are 5-30 mm long and 3-10 mm wide. Grains are geometrically randomly oriented at the whole sample.

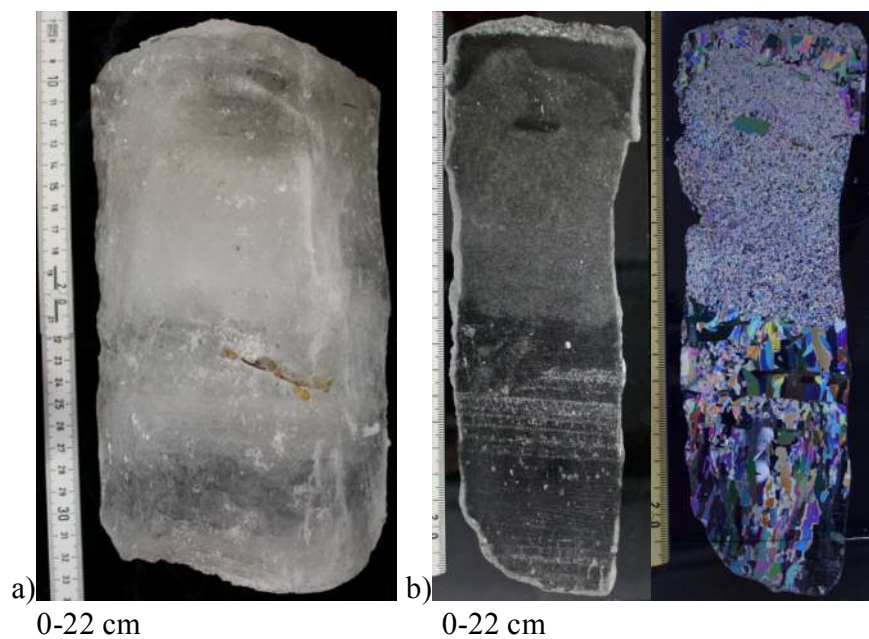
Figure 9. Kymi4 ice samples a) whole ice block, b) thick sample in normal light (left) and thin section in polarized light (right).

At the sampling site Kymi4 there was only some border ice. The total ice thickness was 22 cm and there was 10 cm of snow on top of the ice. The ice sample was taken from the southern bank of the river. Sampling site was approximately 20 meters downstream from gate-structure dam. From the full vertical ice sample in Figure 9-a it can be seen that the top 11 cm is opaque ice with a lot of gas bubbles and the bottom 11 cm is quite clear ice. There is a cloudy band layer 14-16 cm from top.

It can be seen from the thick section (Figure 9-b) that the first 11 cm contains a lot of small gas bubbles (diameter < 1 mm). There is a clear layer 0.5-2 cm from top. There are bed sediments in the layer that is 2-7 cm from top. This layer is probably the first ice layer which is formed from the frazil ice that was attached to the bottom and bed sediments stuck on it before it reached enough buoyancy to float. The bottom 11 cm layer is quite clear with few cloudy bands.

It can be seen from the thin section (Figure 9-b) that the top 11 cm has really small grains (diameter < 1 mm). This layer has formed from the frazil ice. There is a layer (0.5-2 cm from top) where there are much bigger grains (5-10 mm long and 1-5 mm wide). This layer has probably formed from the water that flooded on top of the ice. The bottom 11 cm layer is congelation ice where the grains are columnar (10-40 mm long and 1-10 mm wide).

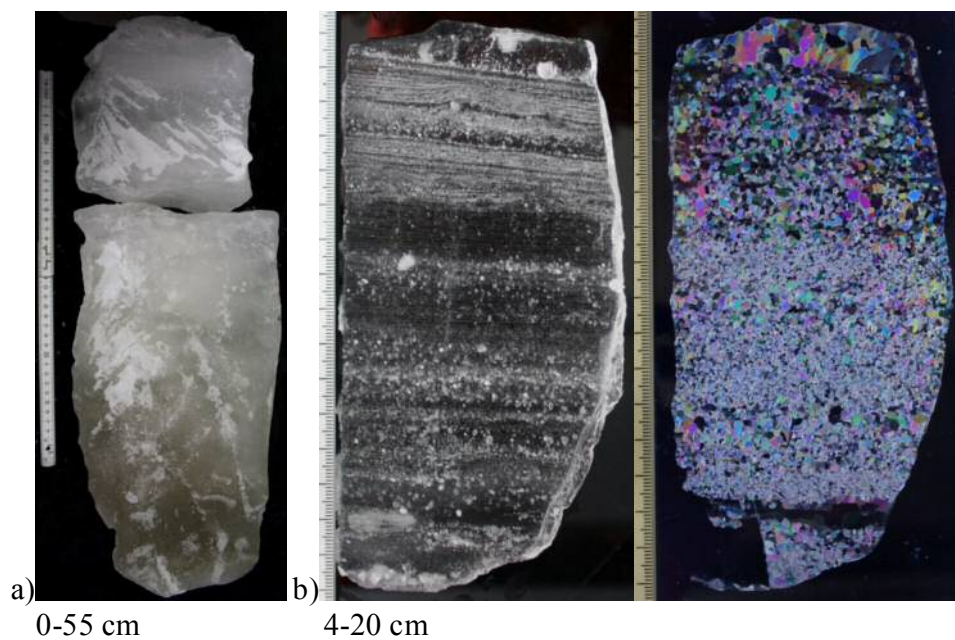
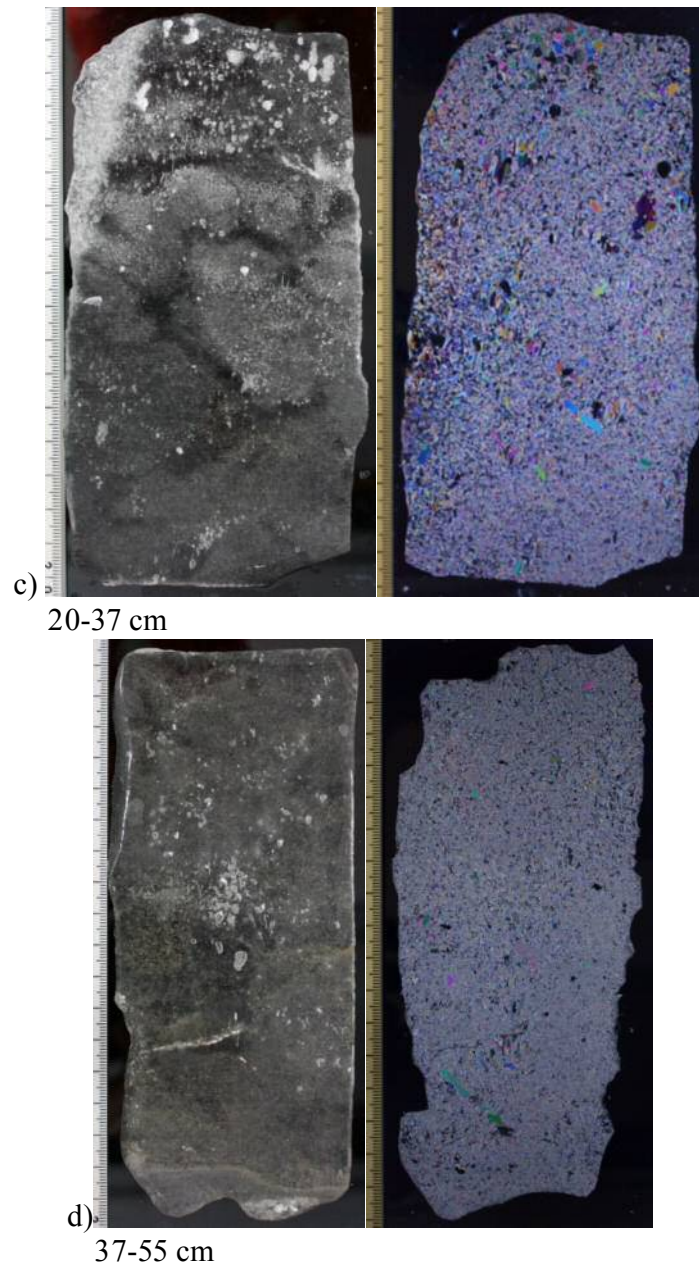
Figure 10. Kymi5 ice samples a) whole ice block, b), c) and d) thick sample in normal light (left) and thin section in polarized light (right).

At the sampling site Kymi5 there was a stationary ice cover. The total ice thickness was 55 cm and there was approximately 23 cm of snow on top of the ice. Sampling site was approximately 20 meters downstream from frazil ice boom that was broken during the winter because of high surface flow. From the full vertical ice sample in Figure 10-a it can be seen that the whole ice sample is opaque ice with a lot of gas bubbles. At the lower part of the sample (40-55 cm from the top) there are a lot of bed sediments. The ice sample broke into three pieces (0-4 cm, 4-20 cm and 20-55 cm). Top layer (0-4 cm) broke during the processing so it wasn't analyzed.

It can be seen from the thick section (Figures 10-b, 10-c and 10-d) that the top 5-10 cm layer has a lot of small (< 1 mm) gas bubbles in horizontal rows. This layer was probably formed from the snow. Next 10 cm layer has few more clear layers where is only few small (< 1mm) gas bubbles and opaque layers that has a lot of gas bubbles which diameter is approximately 1 mm. Some of these layers are probably the first ice layer and it has pushed the bubbles downwards when it froze. Rest of the ice sample has a lot of small (< 1 mm) gas bubbles which are in bunches with more clear ice in between. This layer has probably formed from the frazil flocs which froze under the solid ice cover.

It can be seen from the thin section (Figures 10-b, 10-c and 10-d) that the top layer (4-5 cm from top) has columnar grains (2-10 mm long and 1-5 mm wide). This layer has probably formed from snow that was melted because of the rain or warm weather. Next layer (5-10 cm from top) has small rounded grains which diameter is approximately 1-3 mm. Rest of the sample has really small grains (< 1 mm) that layer has probably formed from frazil ice.

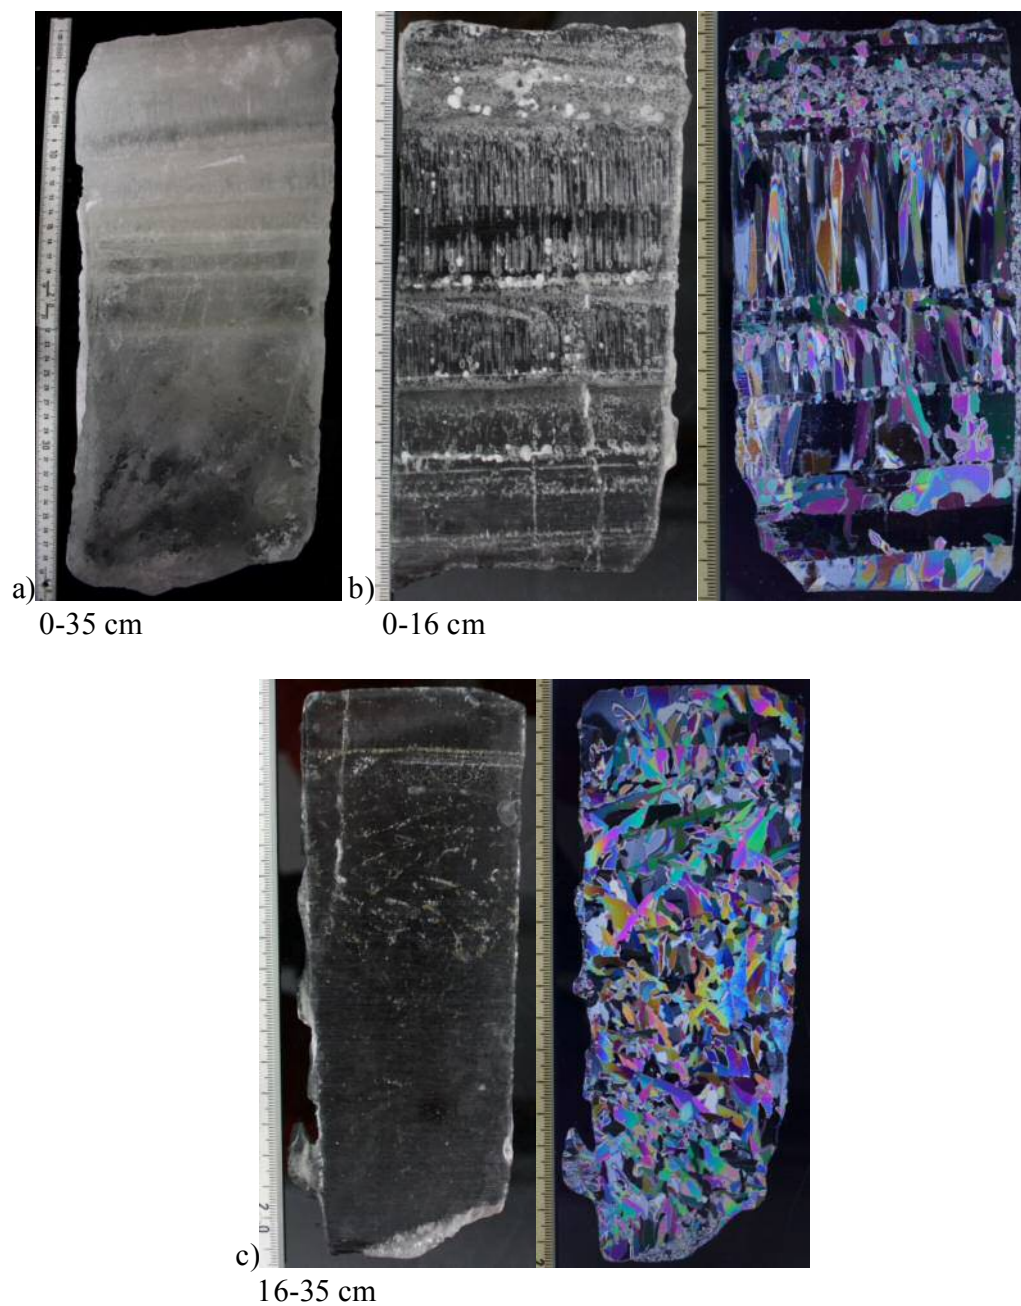
Figure 11. Kymi6 ice samples a) whole ice block, b) and c) thick sample in normal light (left) and thin section in polarized light (right).

There was a stationary ice cover at the sampling site Kymi6. The total ice thickness was 35 cm and there was 15 cm of snow on top of the ice. At the middle of the river there was some partly melted snow. From the full vertical ice sample in Figure 11-a it can be seen that the top 15 cm layer is opaque ice with a lot of gas bubbles and the rest of the ice is quite clear ice.

It can be seen from the thick section (Figures 11-b and 11-c) that the top 3 cm layer has a lot of small (< 1 mm) gas bubbles. Next layer (3-10 cm from top) has a lot of vertical gas catchments which are 3-20 mm long and 1 mm wide. These layers have formed rapidly because of really

cold temperature and ice could not push the gas bubbles away when it froze. Rest of the sample is quite clear ice with only few small (< 1 mm) gas bubbles.

It can be seen from the thin section (Figures 11-b and 11-c) that the top 0.5 cm layer has grains which diameter is approximately 3 mm. Next 0.5 cm layer has one big grain which is approximately the size of the whole layer. These layers were probably formed from the water that flooded on top of the ice or melted snow. Next layer (1-3 cm from the top) has small grains (diameter 1-3 mm). Rest of the sample is congelation ice. At the top of the congelation ice layer (3-16 cm from top) there are columnar grains which geometrical alignment is vertical. Grains are 20-50 mm long and 3-10 mm wide. There are also some frazil ice grains in between. Bottom part of the congelation ice (16-35 cm from top) has grains which are 2-30 mm long and 1-5 mm wide. Geometrical alignment is more random with these grains.

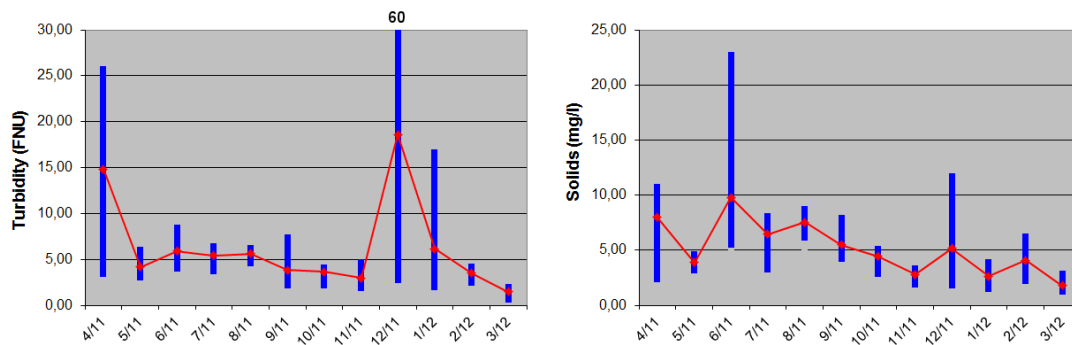
Figure 12. Turbidity and solids at River Kymijoki (4/2011-3/2012). Red line is average and blue column is range (OIVA - Environment and geographical information service for specialists 2012).

Both turbidity and sediment concentration are highly dependent of erosion and runoff, and therefore peaks occur often after rain events. Sediments are also dependent of primary production in the river and lakes that can be seen in high values during June 2012 (Figure 12). Turbidity is determined mostly from the runoff, and the influence of the high precipitation at the end of the year 2011 is clearly visible in the figures. Some points also show peak in sediment concentration at that same time (Figure 14). Turbidity and sediment level increase when moving downstream (Figure 13).

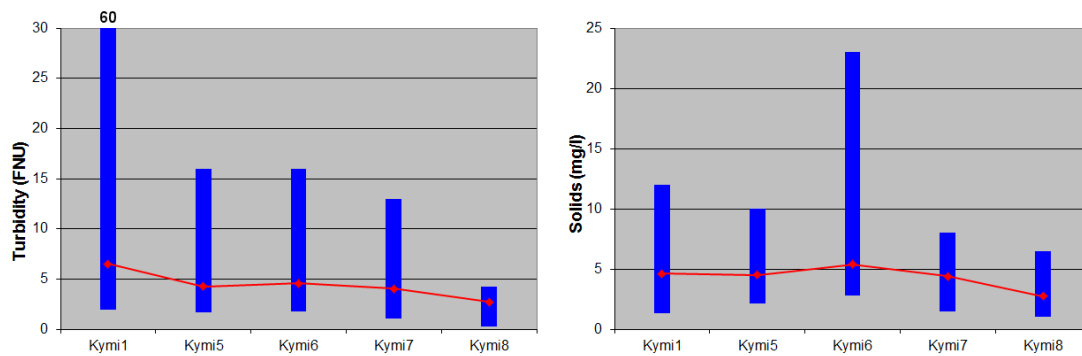
Figure 13. Turbidity and solids at different measurement points at the River Kymijoki (4/2011-3/2012). Red line is median and blue column is range (OIVA - Environment and geographical information service for specialists 2012).

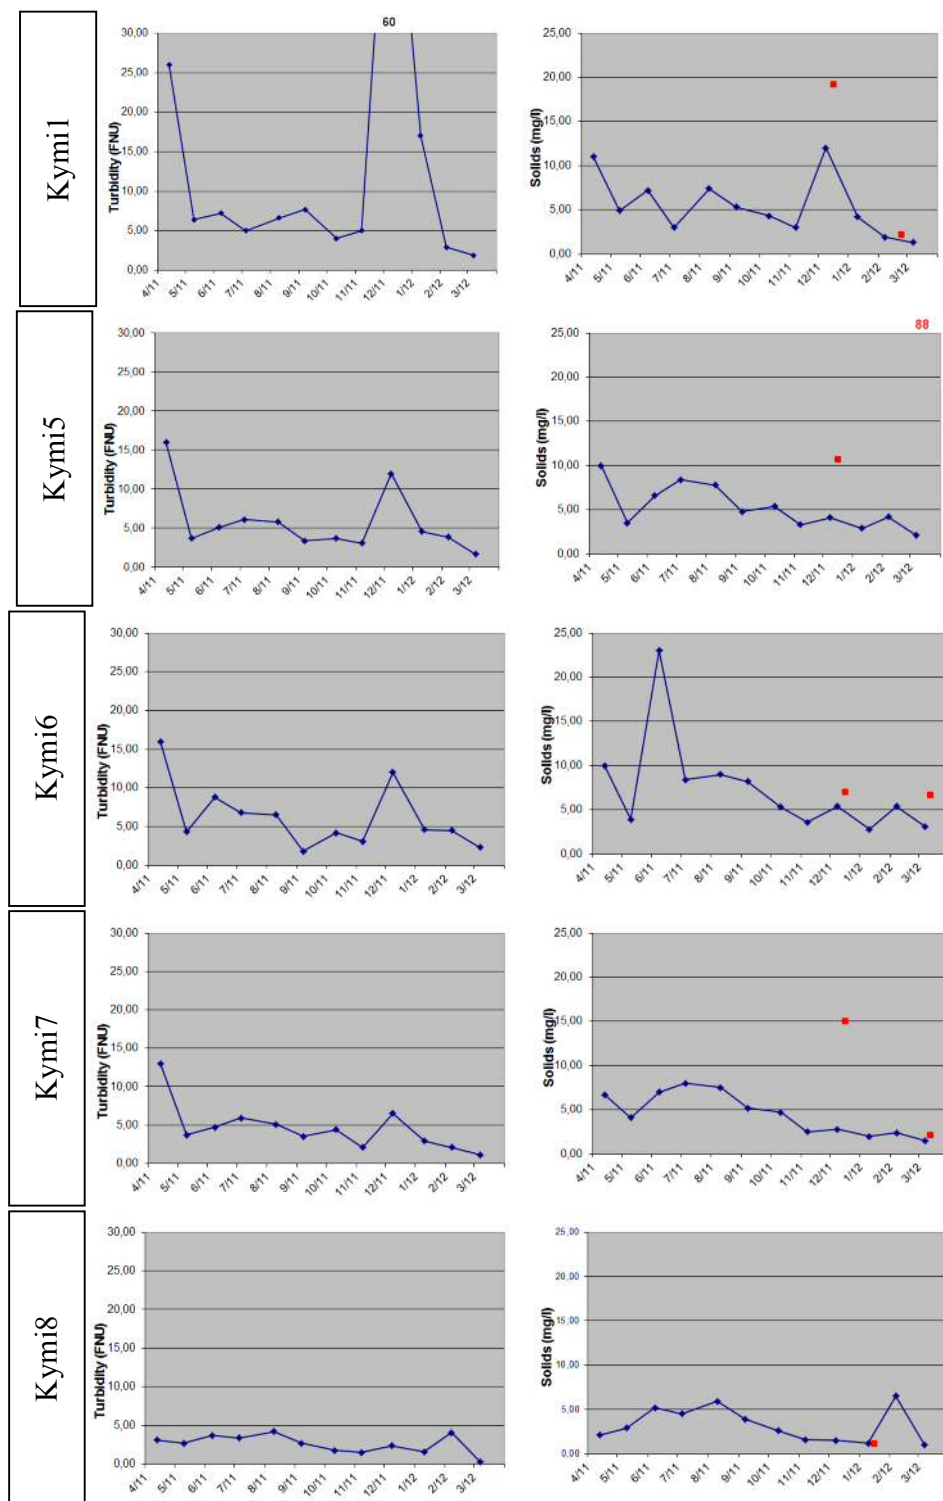
Figure 14. Turbidity and solids at the River Kymijoki measurement points (blue line is Kymijoki Water and Environment Associations measurements, red dots are own measurements) (OIVA - Environment and geographical information service for specialists 2012).

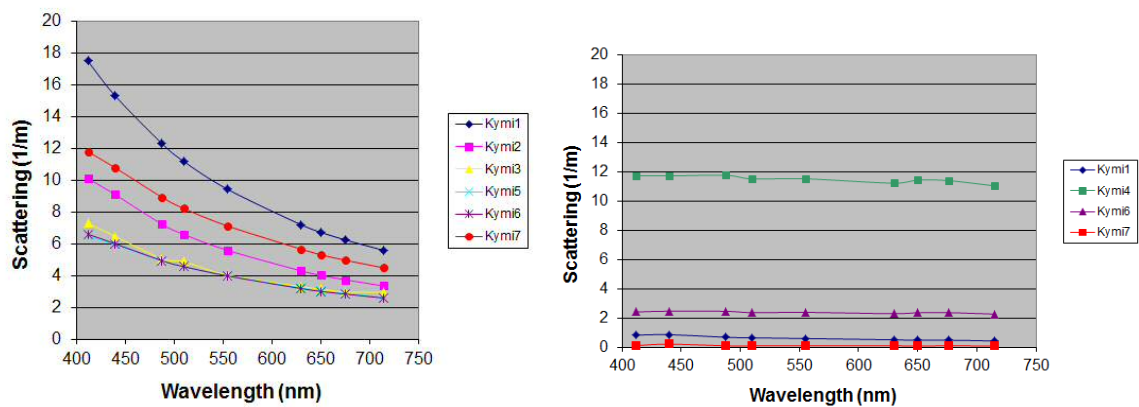
Figure 15. Scattering at the River Kymijoki measurement points during open water season (left) and during ice season (right).

It can be seen from the scattering spectra (Figure 15) that the concentration of particles increases downstream. Upstream points have quite low scattering level except for Kymi7 that is downstream from a water treatment plant. In the upstream points (Kymi9, 10 and 11), attenuation and absorption was so low that scattering could not be estimated from the measurements.

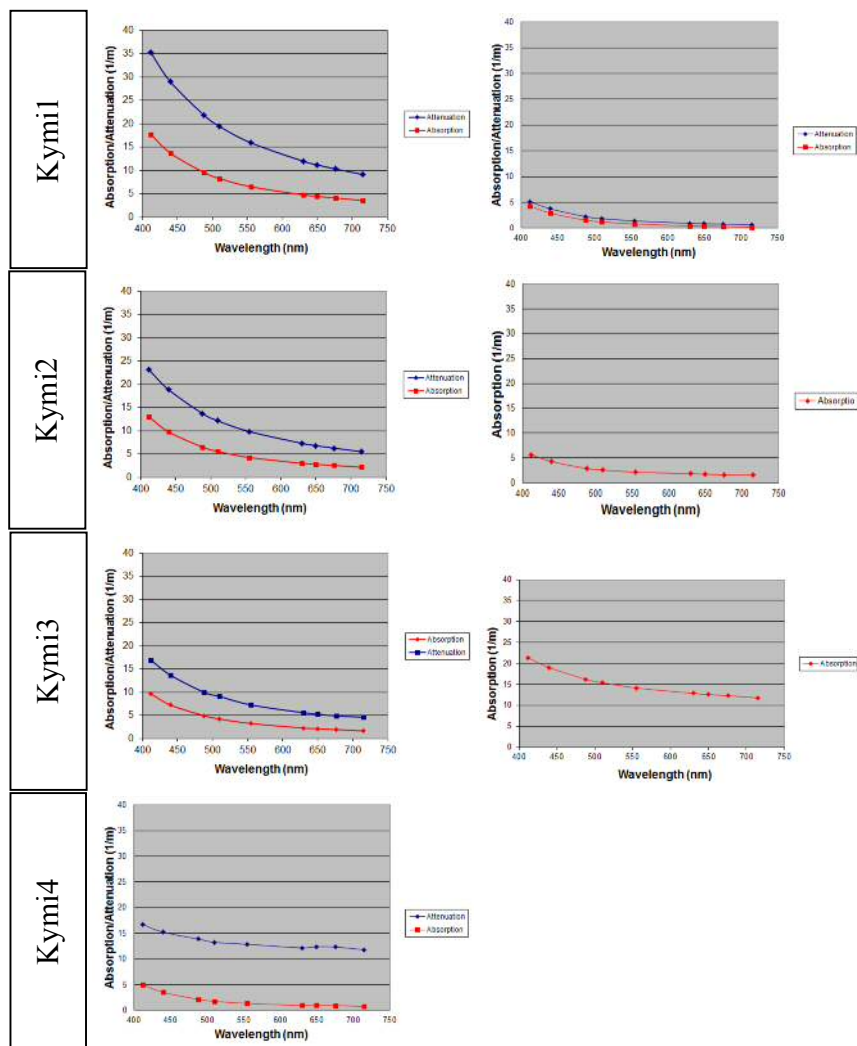
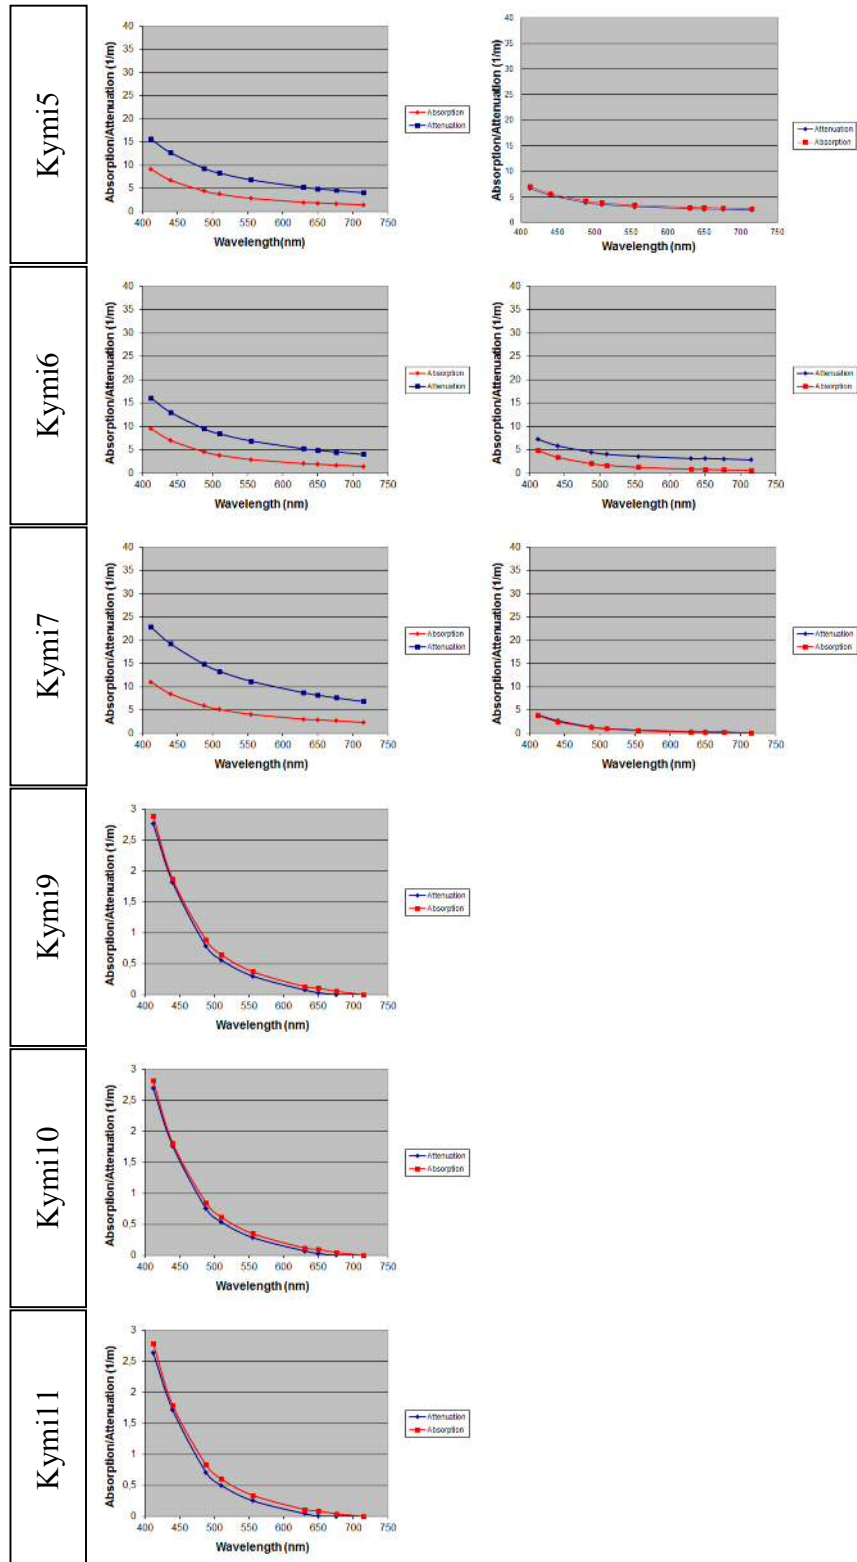
Figure 16. Absorption (red line) and attenuation (blue line) at different River Kymijoki measurement points. Open water measurements at left and ice season measurements at right.

Scattering was quite uniform at all wavelengths during the winter and there was much less scattering except at site Kymi4. Absorption and attenuation were much lower at every point during winter except at point Kymi3 (Figure 16).

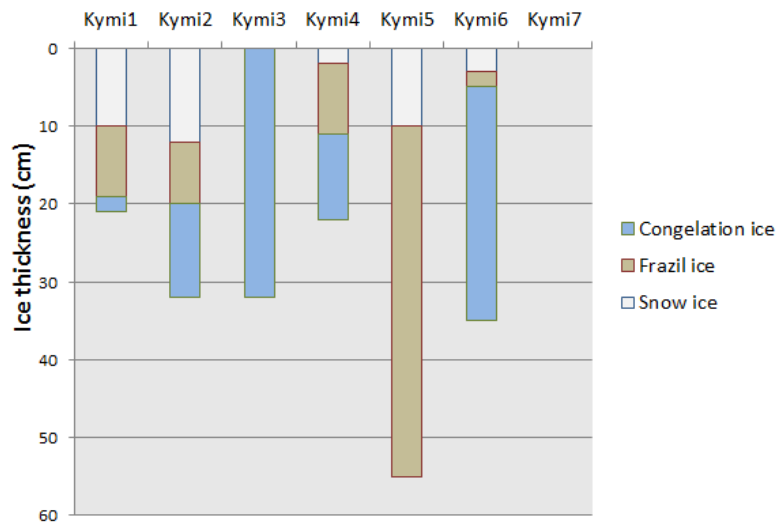
Figure 17. Ice structure at River Kymijoki measurement points.

There was a lot of variation in the ice structure and thickness between different measurement points, because of ice control structures and different discharge. Ice structure at measurement points is shown in Table 1 and Figure 17.

At the measurement points, where the river discharge was higher ($> 200 \text{ m}^3/\text{s}$) there was only some border ice (Kymi1, -3 and -4) or no ice at all (Kymi7). Frazil ice boom seemed to work well at measurement point Kymi3, where the ice cover was entirely congelation ice. Frazil boom had formed insulating ice cover upstream from point Kymi3 and there was no frazil ice flow to the measurement point. Frazil boom upstream from point Kymi4 didn't seem to have noticeable effect on the ice structure.

At the measurement points, where the river discharge was lower ($< 200 \text{ m}^3/\text{s}$), there was a stationary ice cover. Frazil ice boom seemed to work well and it collected flowing frazil ice at downstream from measurement point Kymi5, where ice cover was entirely frazil ice. It was also the thickest ice cover (55 cm) of all the measurement points. Also the frazil boom upstream from the measurement point Kymi6 seemed to work well. Ice structure showed that there were really cold periods but there was not much frazil ice in the ice sample. The frazil boom had formed a well insulating ice cover and there was no frazil ice flow to the measurement point.
